# **Flat Roof Condition Survey**

## **Baron Square HOA**

**Palo Alto, CA**

**August 2013**

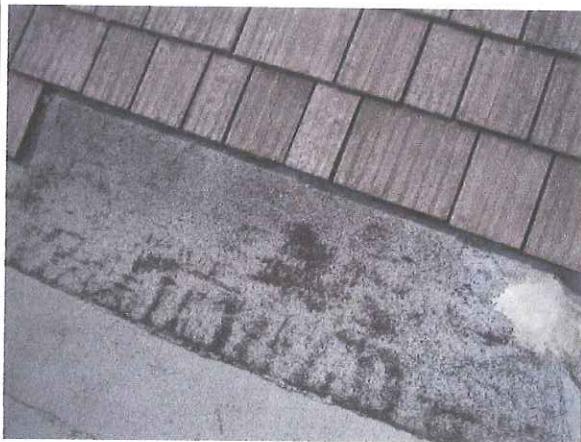
**Observation:**

Granule deterioration has occurred at SBS Modified Bitumen base flashing. This is a common occurrence for this product.

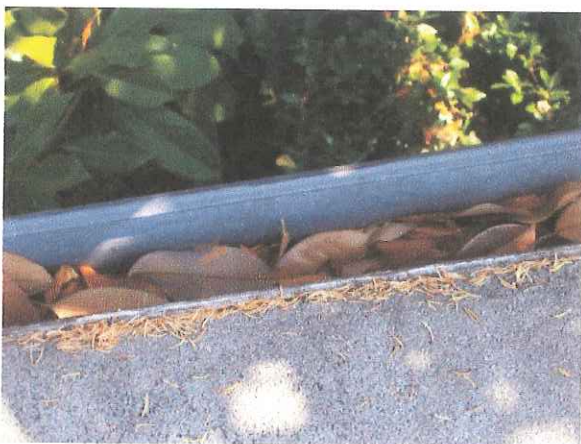
**Observation:**

Debris in gutters is inhibiting drainage. This is a maintenance item and can affect the roof longevity.

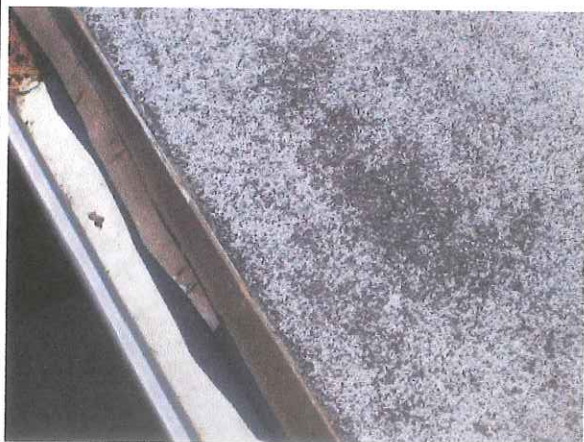
**Observation:**

Granule loss on field cap sheet indicating the roof is nearing the end of its useful life.

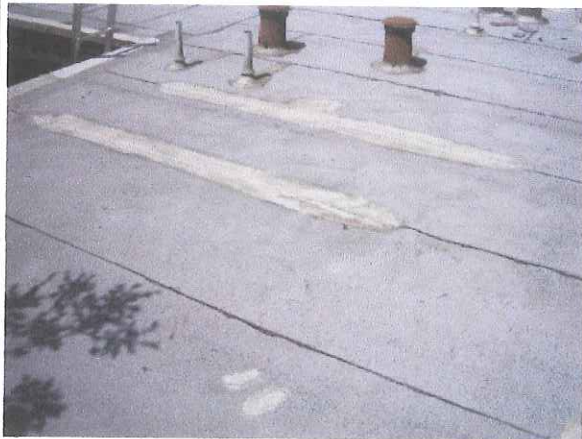
**Observation:**

Evidence of extensive repairs on roof membrane.

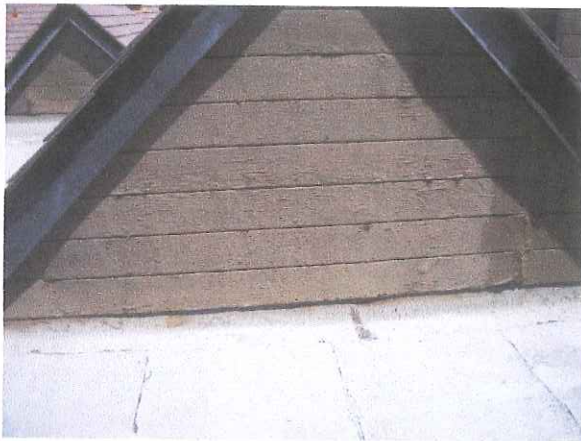
**Observation:**

Note deteriorated siding at clear story. Leaks from the siding could be mistaken as roof leaks.

At a minimum, all of the buildings and utility closets should be roofed this year and the clear story siding should be replaced.

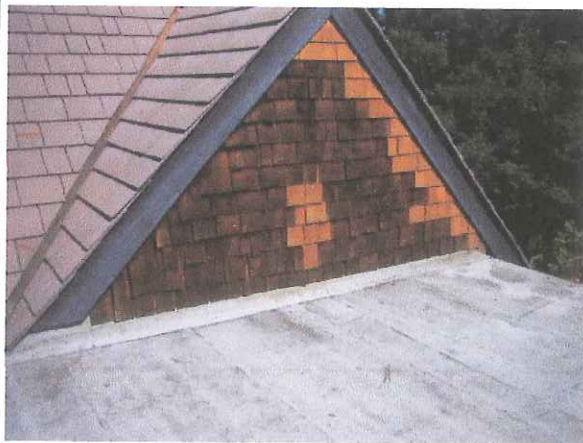
**Observation:**

Evidence of some siding repairs at clear story.

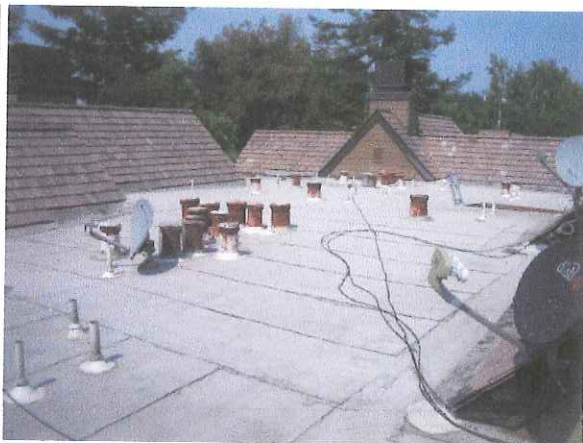
## Building 1

General view of main flat roof.

**Condition:**

Fair to Poor

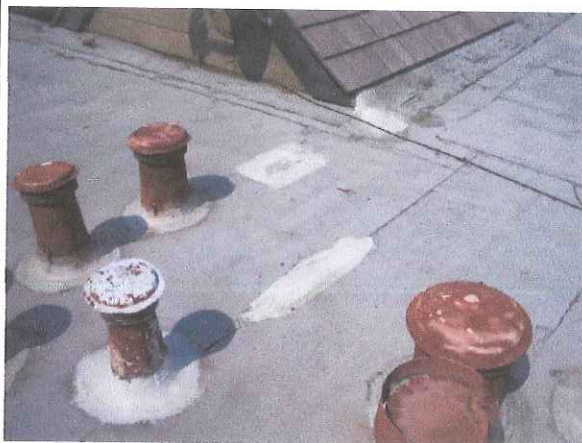
This roof did have the fewest repairs observed however the roof leaked in the recent past.

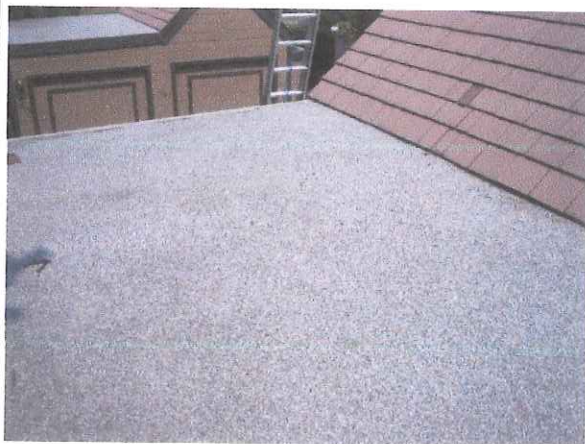
## Garage 4104

View of gravel roof.

**Condition:**

Fair

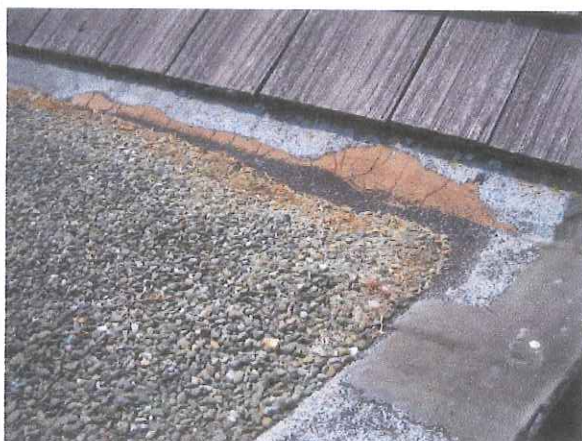
### Garage 4112

Evidence of some repairs.

**Condition:**

Fair to poor

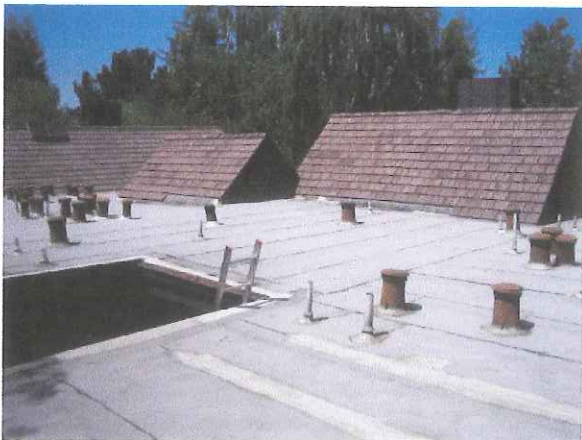
### Building 2

General view of main roof, note numerous repairs.

**Condition:**

Poor

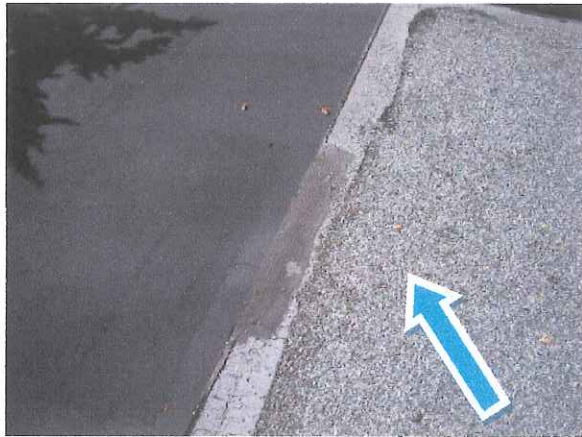
| | <p><b>Observation:</b></p> <p>Evidence of repairs at roof edge.</p> |

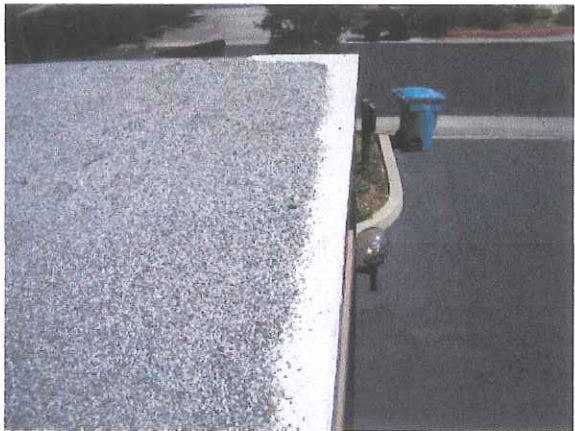
#### Garage 4122

| | <p><b>Observation:</b></p> <p>Evidence of repair at roof edge.</p> <p><b>Condition:</b></p> <p>Fair to poor</p> |

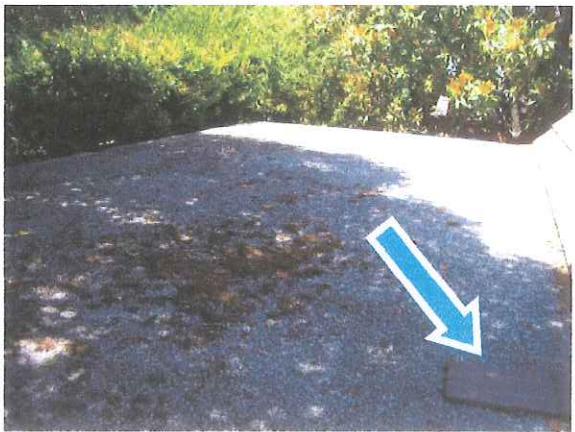
#### Garage 4130

| | <p><b>Observation:</b></p> <p>Some debris on roof, note fallen cementitious shingle.</p> <p><b>Condition:</b></p> <p>Fair</p> |

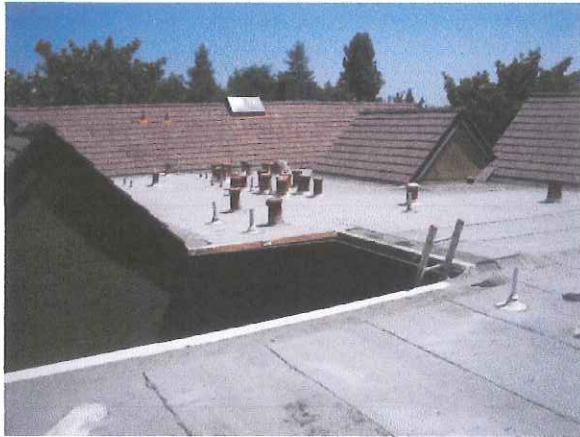
**Building 3**

General view of main roof.

**Condition:**

Poor

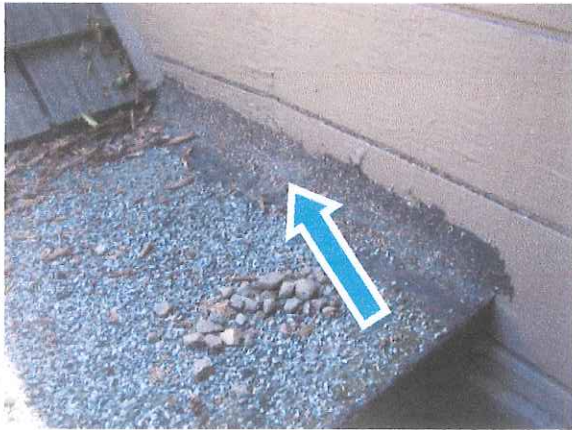
Note repair at roof edge to wall on small utility closet.

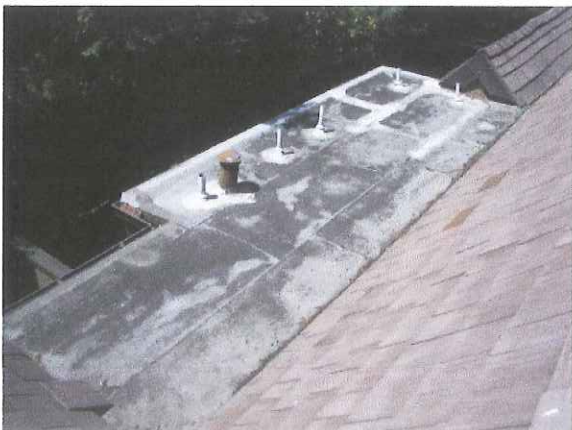
Again extensive granule loss.

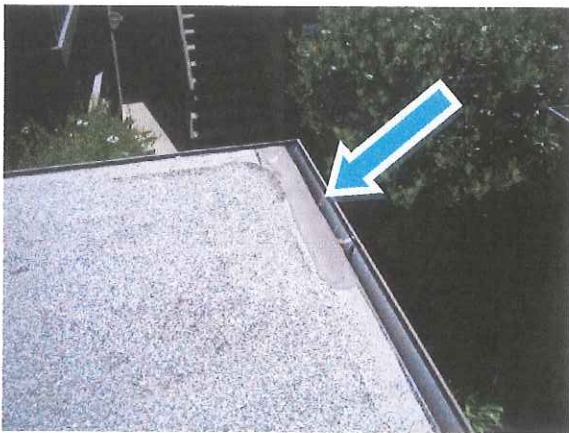
### Garage 4148

Note repair at roof edge.

**Condition:**

Fair

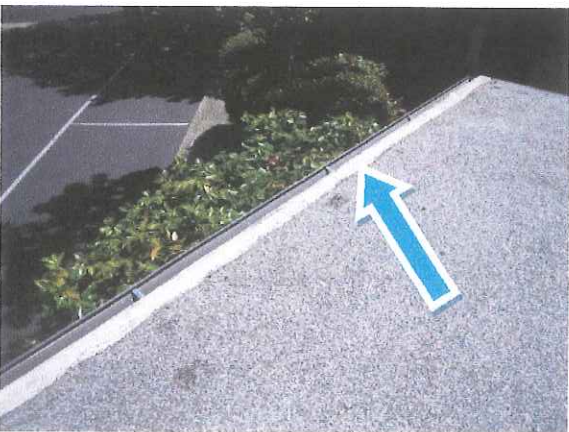
### Garage 4144

Again, note repair at roof edge.

**Condition:**

Fair to poor

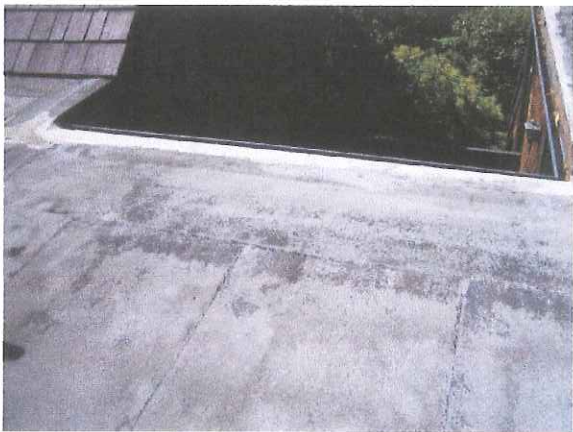
Note extensive granule loss.

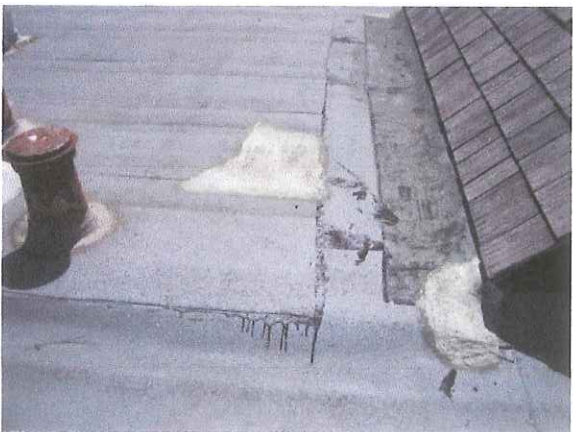
Evidence of numerous repairs.

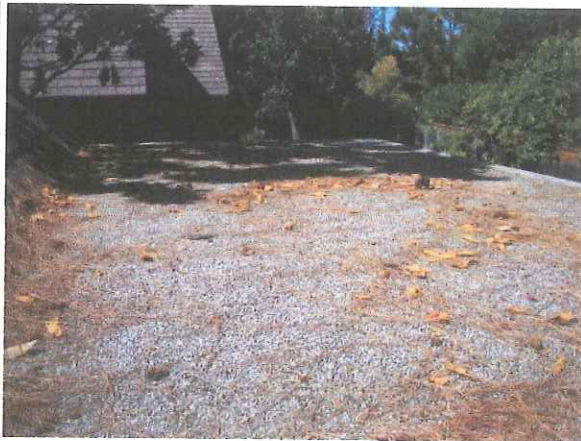
### Garage 4170

View of gravel roof.

**Condition:**

Fair

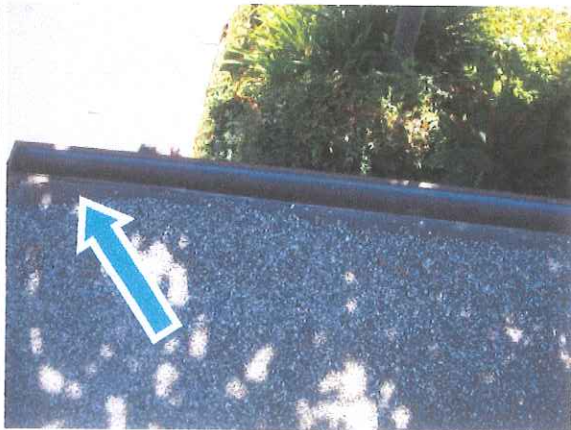
### Garage 4164

Evidence of repair in corner.

**Condition:**

Fair

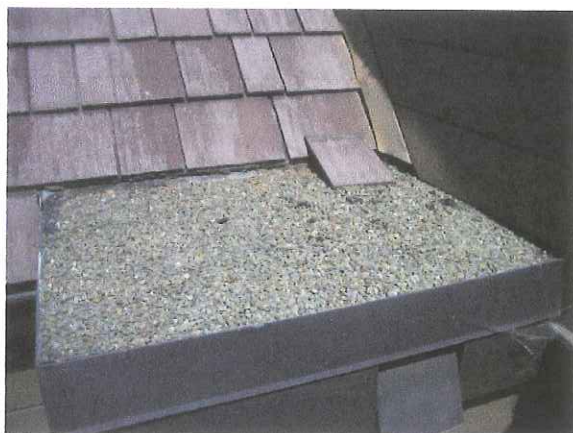
Small utility roof in fair to poor condition. Note fallen shingle.

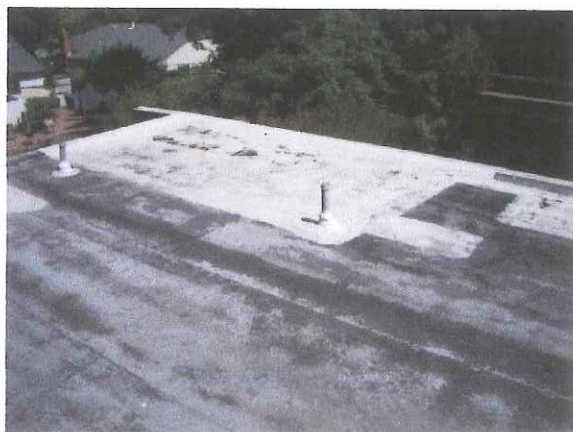
Again evidence of extensive granule loss and large repair.

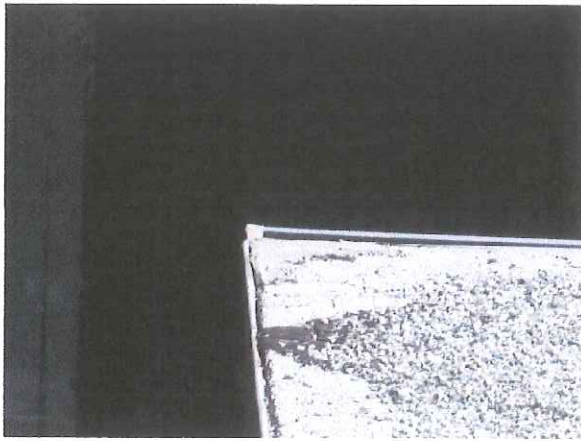
**Garage 584**

Repairs on roof corner.

**Condition:**

Fair

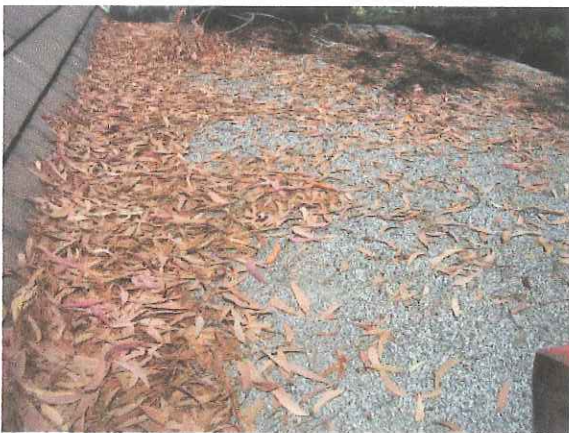
**Garage 590**

Extensive debris on roof can accelerate deterioration.

**Condition:**

Fair

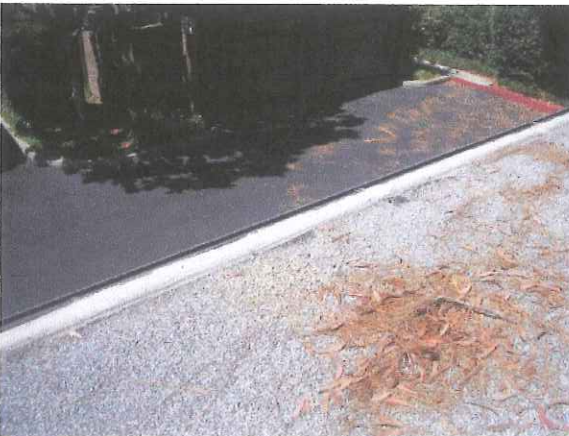
**Garage 588**

Again extensive debris on roof can accelerate deterioration. Note repair at roof edge.

**Condition:**

Fair to poor

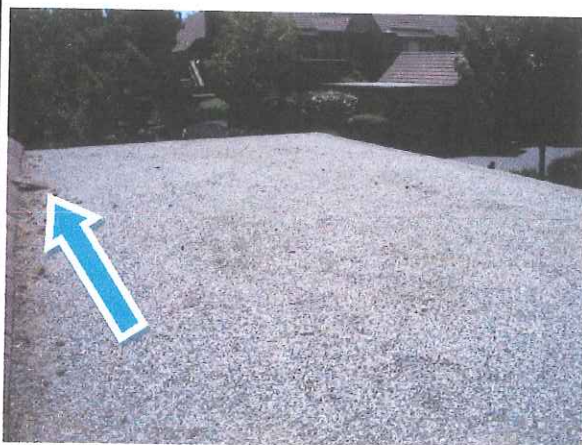
**Garage 586**

View of gravel roof, note fallen shingle.

**Condition:**

Fair

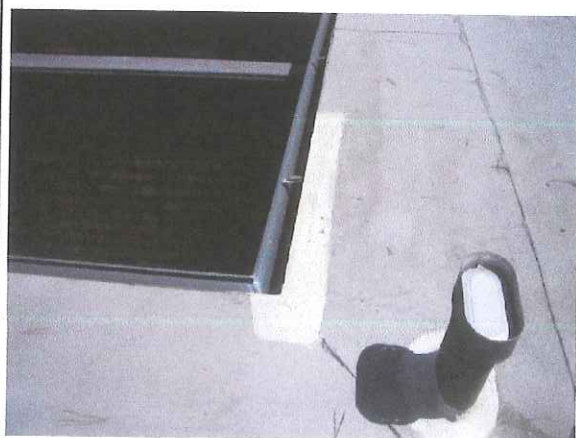
Again roof has many repairs.

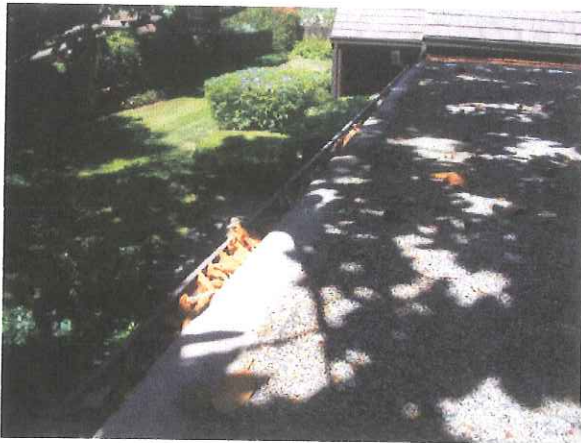
### Garage 564

Note extensive edge repair and debris in gutter.

**Condition:**

Fair to poor

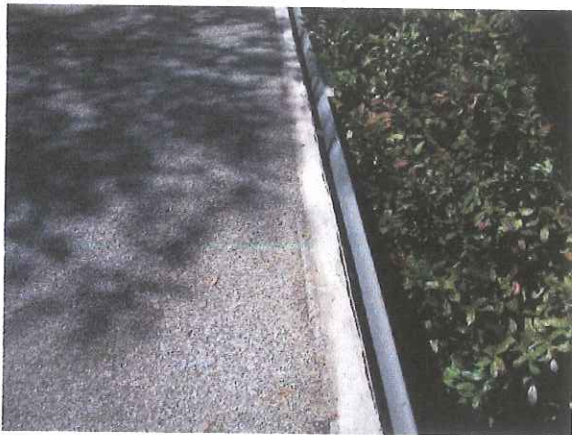
### Garage 562

Again note extensive edge repair.

**Condition:**

Fair to poor

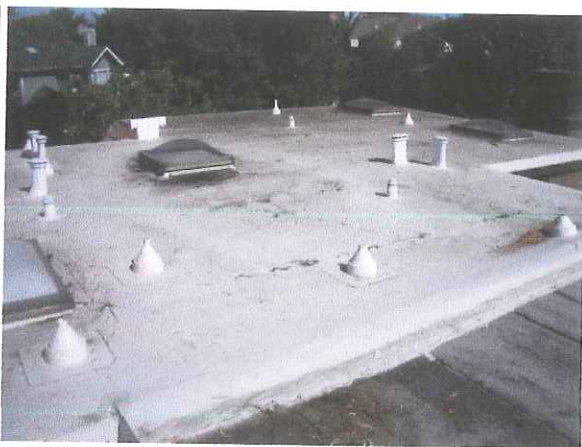
About half of the main roof has been replaced recently with a 60 mil TPO membrane.

**Condition:**

Good

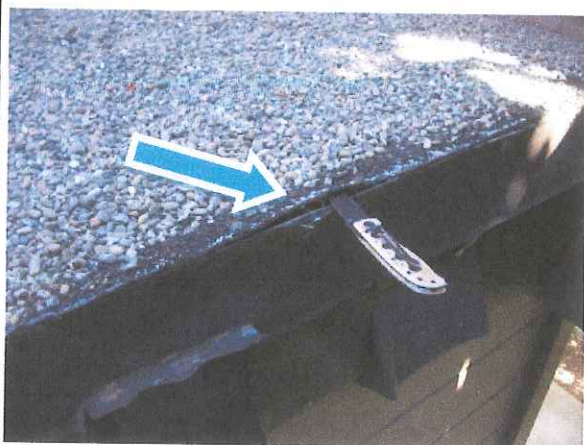
Roof membrane is no longer adhered to metal edge on small utility roof.

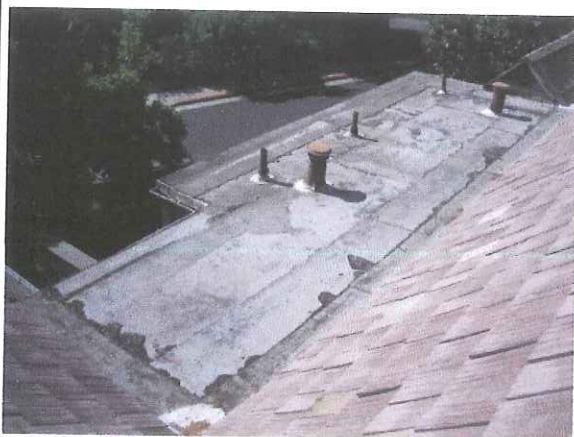
This section of the roof is in very poor condition.

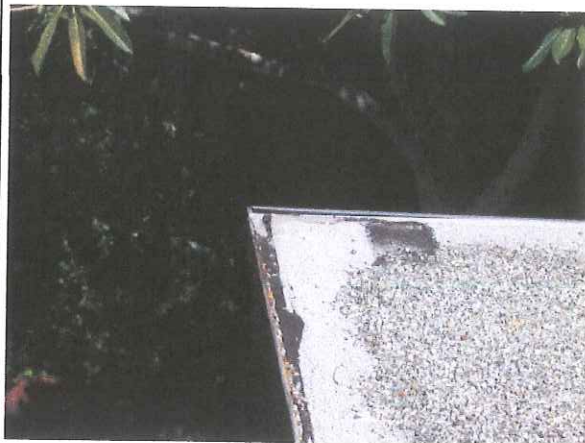
**Garage 550**

Note repair at roof corner.

**Condition:**

Fair

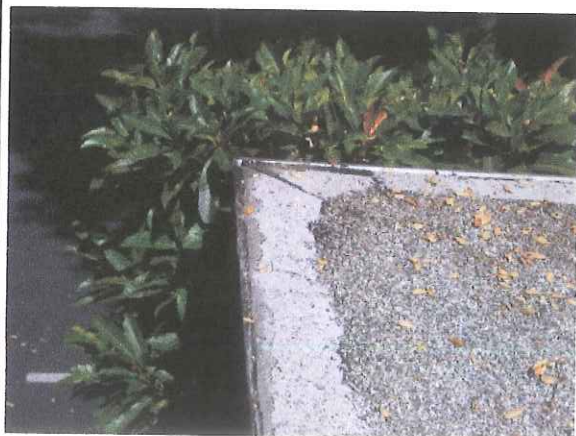
**Garage 548**

Note corner and edge repairs.

**Condition:**

Fair

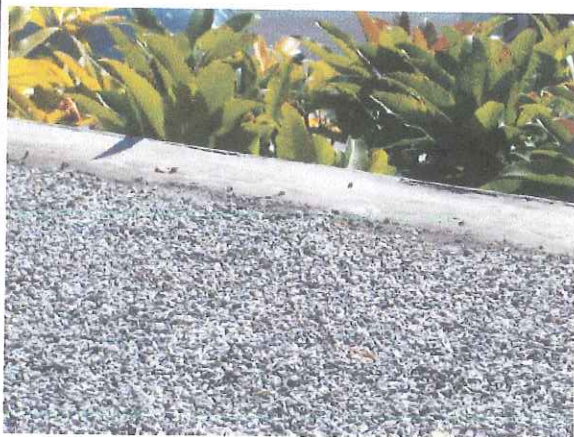
### Garage 542

Again more repairs on edge.

**Condition:**

Fair to poor

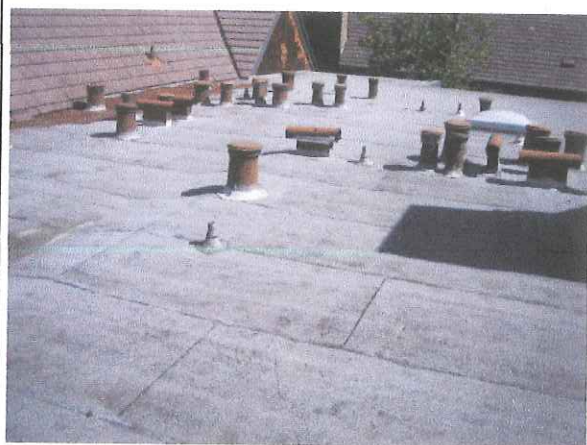
### Building 8

General view of main roof.

**Condition:**

Fair to poor

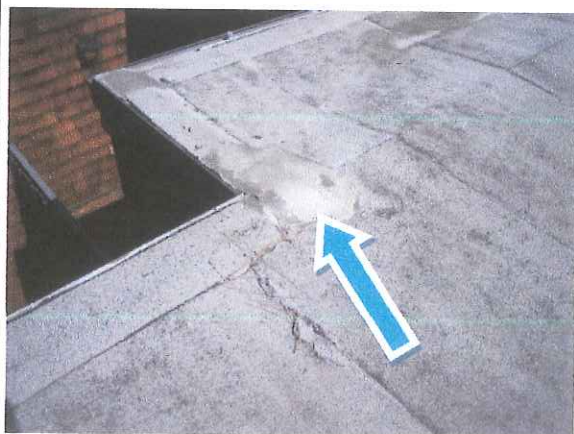
Some repairs were noted on this roof as well, however not as many.

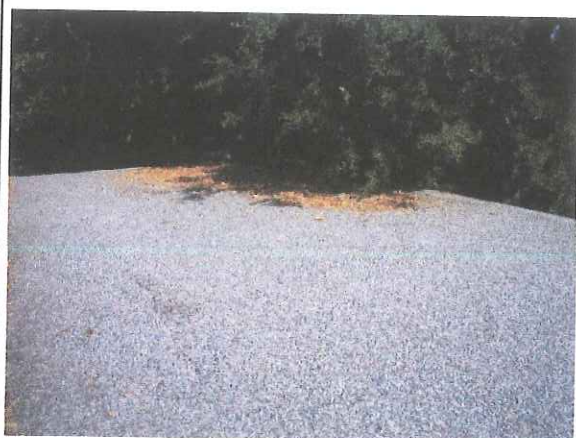
### Garage 524

Note tree overhanging roof depositing debris.

**Condition:**

Fair

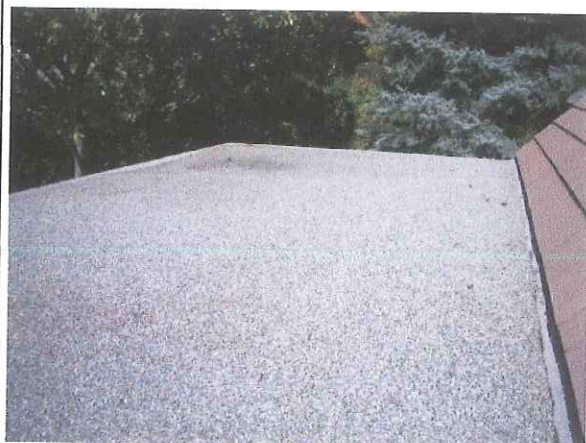
**Garage 526**

View of gravel roof.

**Condition:**

Fair

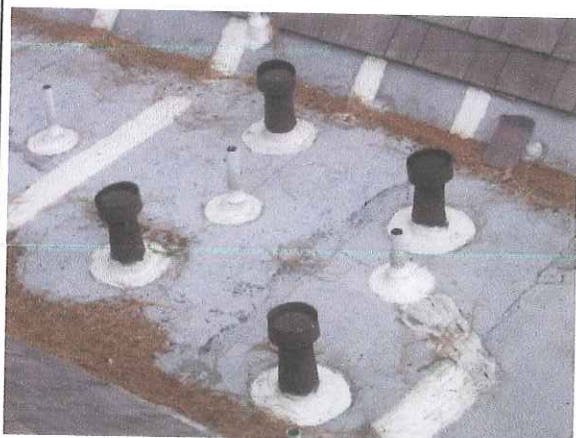
Note the numerous repairs.

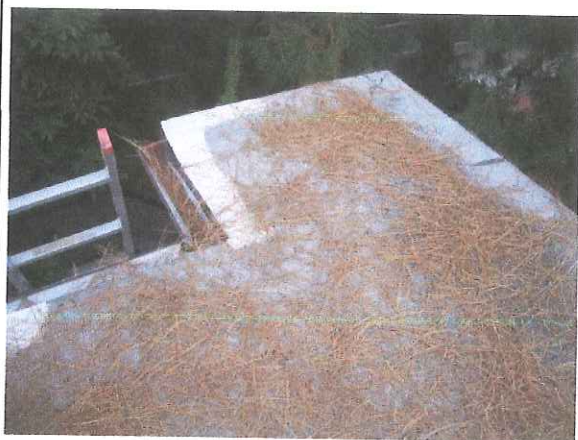
Note debris and repairs.

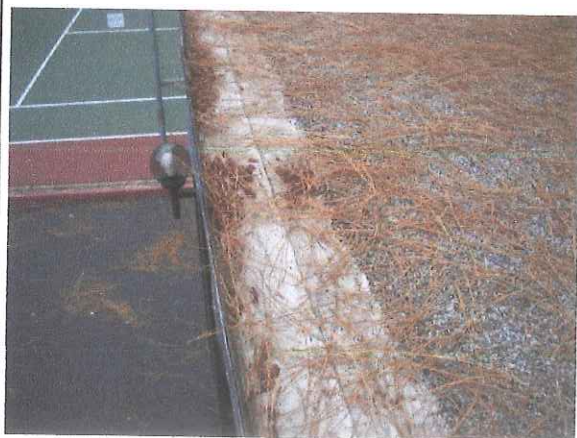
**Garage 506**

Again note debris and repairs.

**Condition:**

Fair to poor

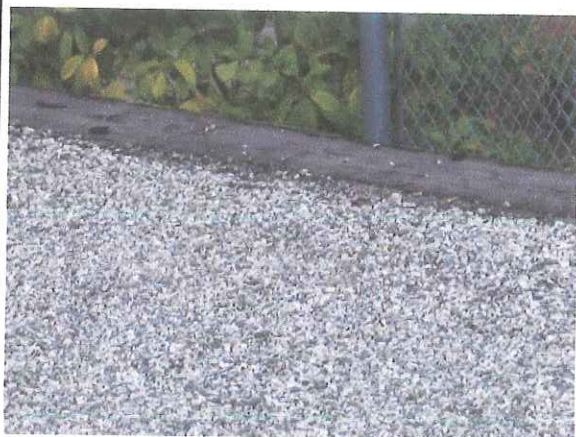
**Garage 504**

Note repair on roof edge.

**Condition:**

Fair to poor

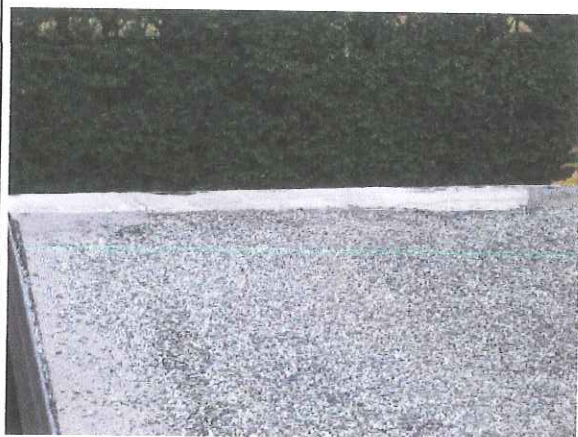
**Garage 512**

Again some repairs on roof edge.

**Condition:**

Fair

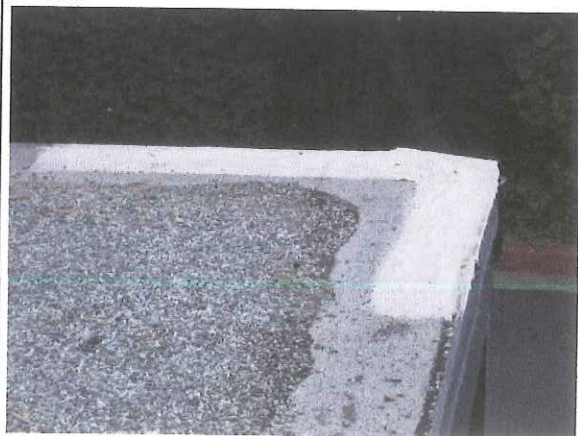
**Garage 514**

Again repairs.

**Condition:**

Fair

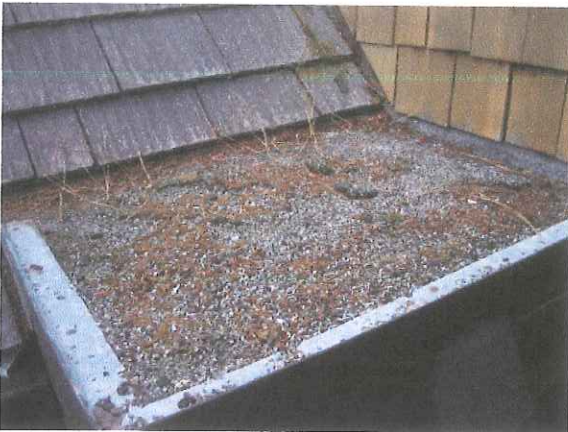
Note repairs on utility flat roof.

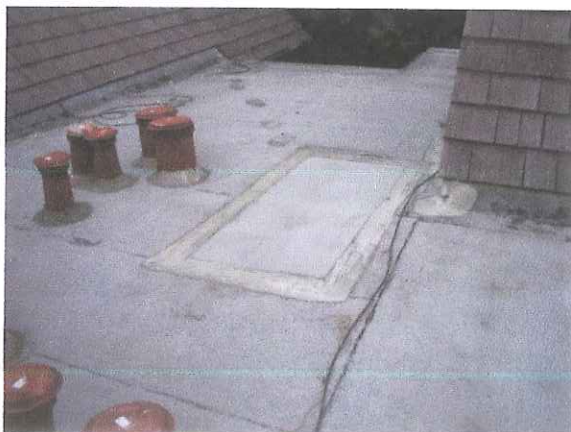
Evidence of major repairs.

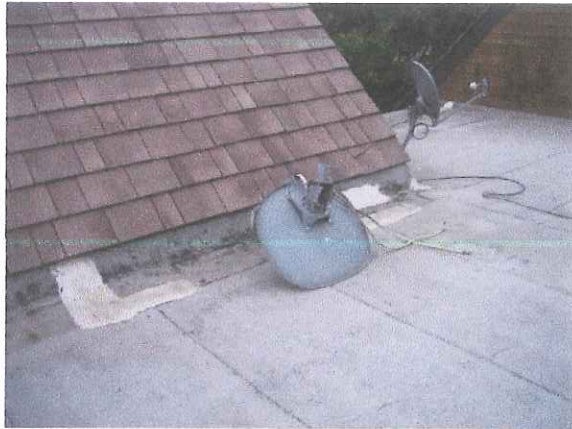
Old satellite dish digging into roof.

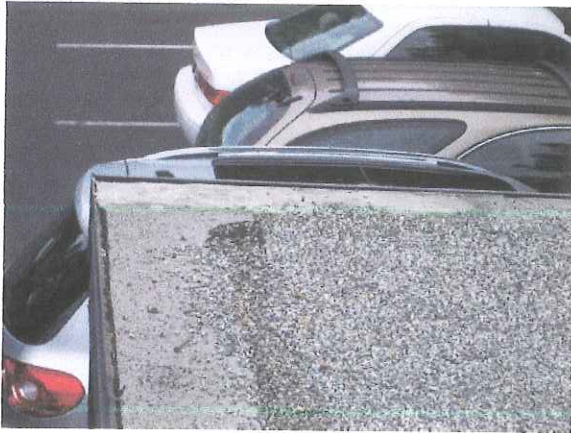
**Garage 531**

Note repair at roof edge.

**Condition:**

Fair

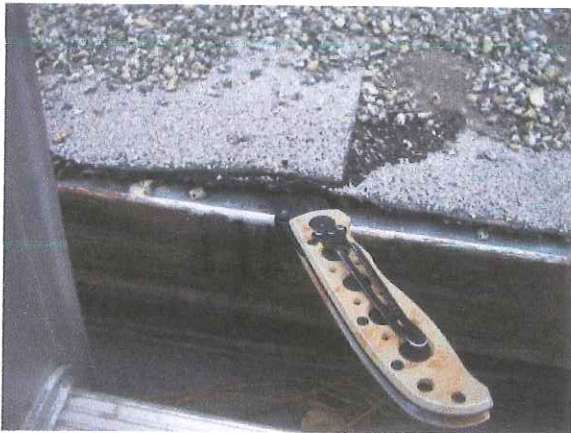
Roof membrane has come loose from metal edge.

**Condition:**

Fair to poor

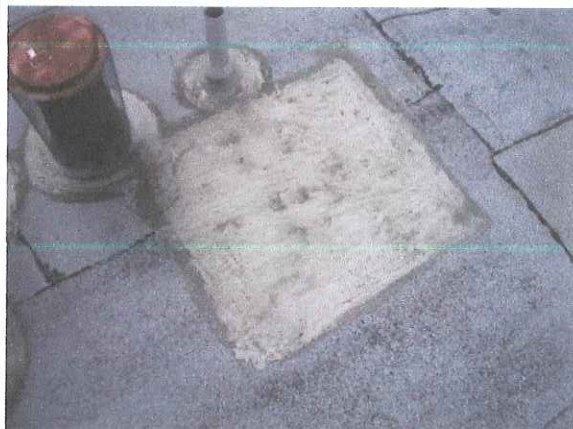
Note repairs on roof.

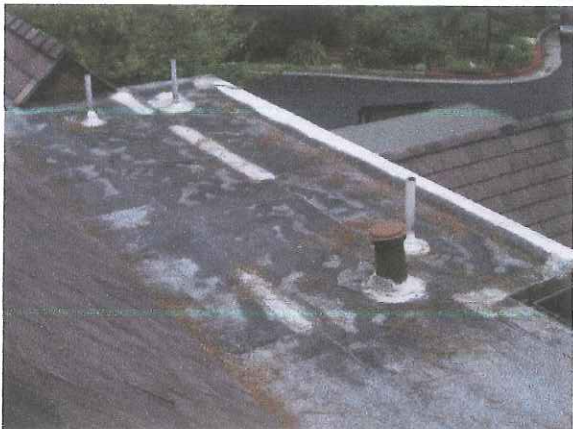
Extensive granule loss and repairs.

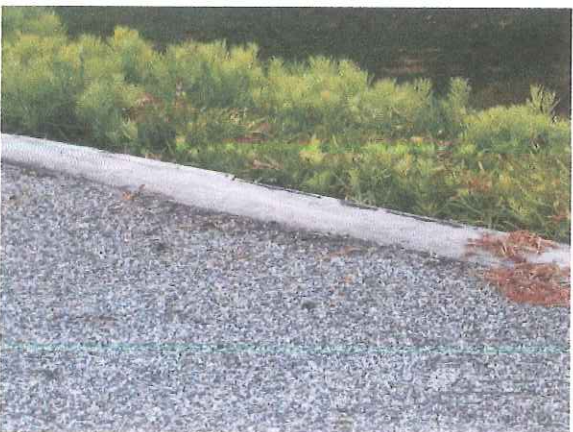
**Garage 559**

Note repair on roof edge.

**Condition:**

Fair to poor

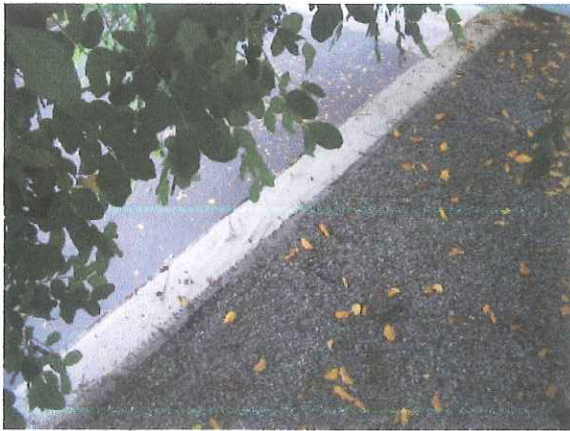
**Garage 555**

Note repair on roof edge.

**Condition:**

Fair to poor

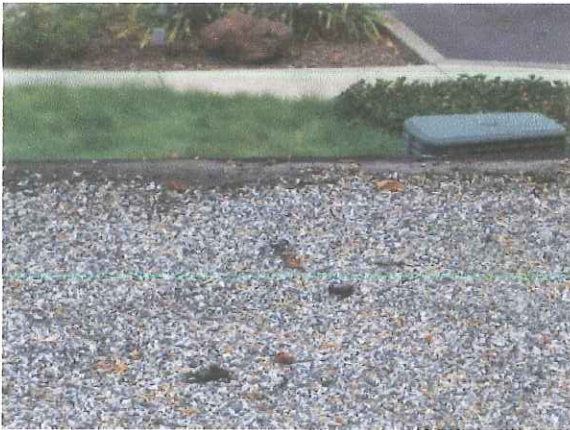
**Garage 559**

Note repair on roof edge.

**Condition:**

Fair to poor

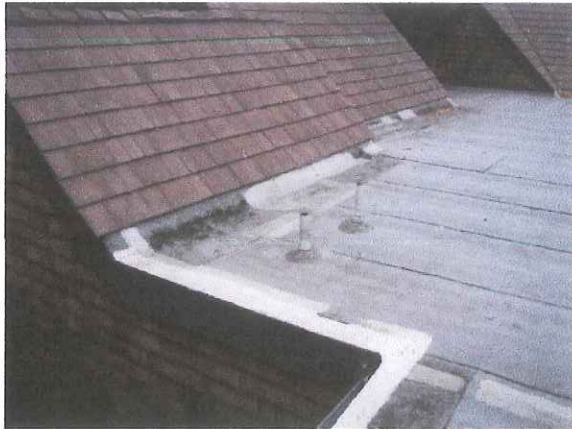
Extensive repairs on roof.

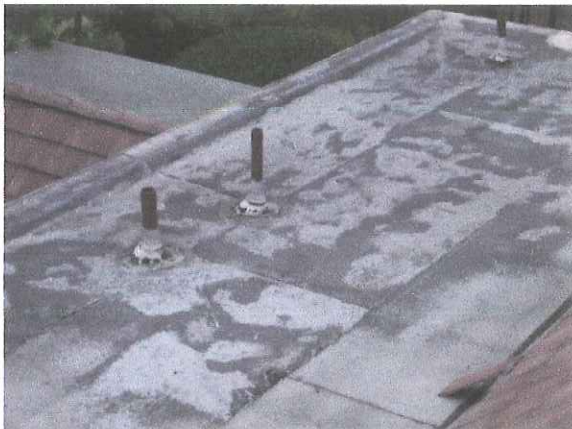
Note extensive granule loss.

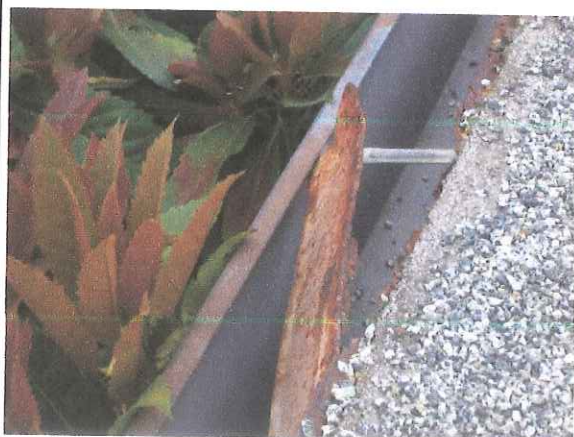
Metal edge of roof has completely rusted away.

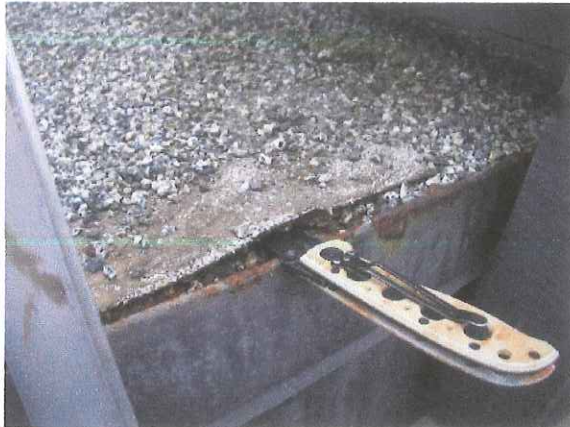
Roof membrane is no longer adhered to metal edge.

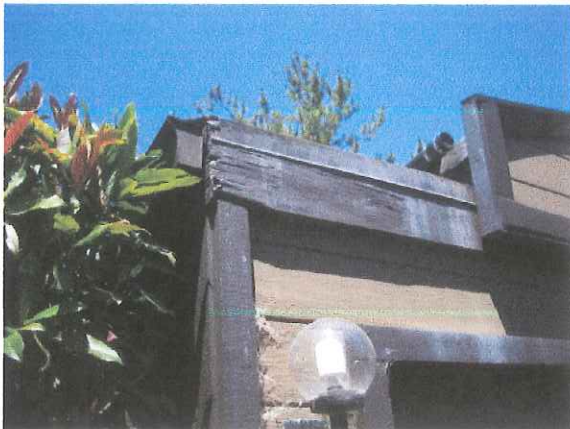
Decayed fascia board was found throughout the complex.

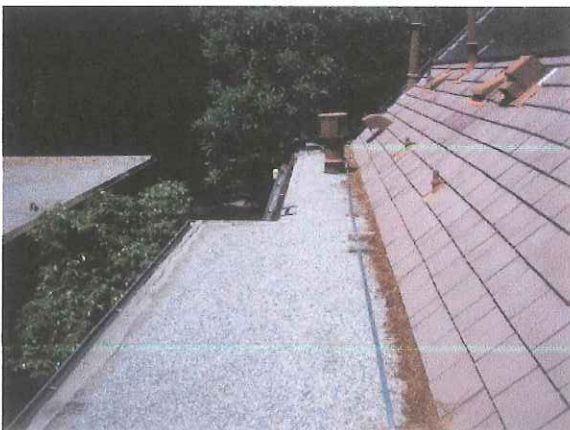
**Clubhouse**

The utility closet roofs are in fair to poor condition as well. In some cases, the asphalt membrane is no longer adhered to the metal edge allowing water to pass the waterproofed surface. The clubhouse roof is in poor condition with evidence of many repairs, new penetrations improperly flashed and solar pipes not sealed well at the penetration point.

General view of roof.

**Condition:**

Poor

If this option is not financially possible the garage roofs could be delayed until next year. It would be possible to also delay the clubhouse if some minor repairs are performed to the penetrations and new flashings as well as the roof edge. Please note some leaks may still occur on these roofs.

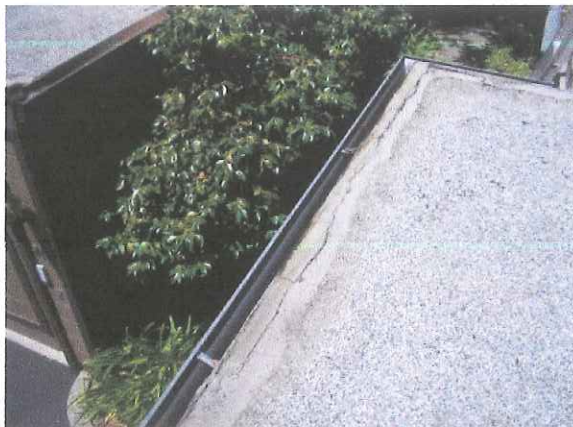
Evidence of repairs at roof edge.

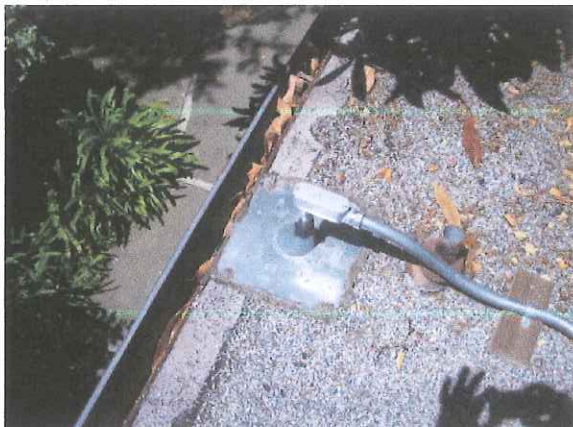
New flashing incorrectly installed and waterproofed for electrical conduit.
