# **Flat Roof Condition Survey**

## **Baron Square HOA**

**Palo Alto, CA**

**August 2013**

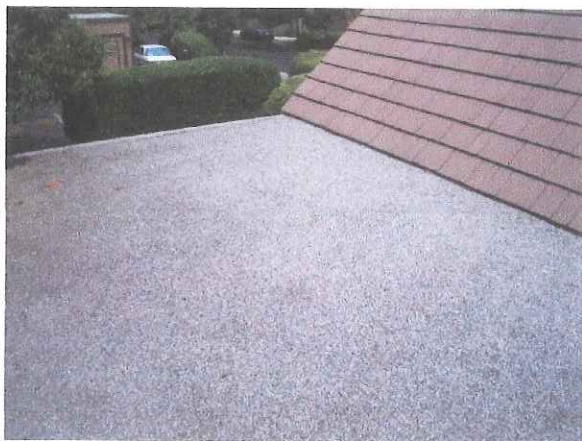
### Garage 4106

View of gravel roof.

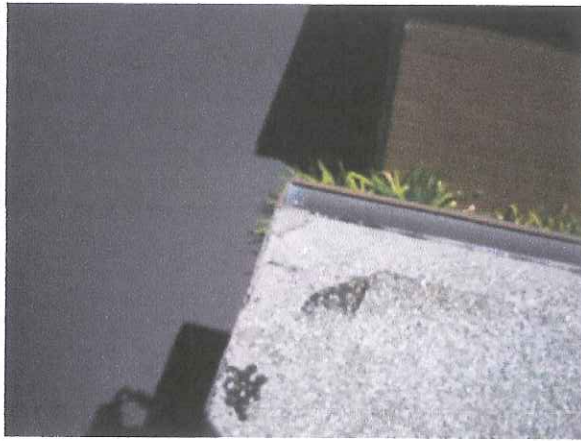
### Garage 4152

Note loss of gravel.

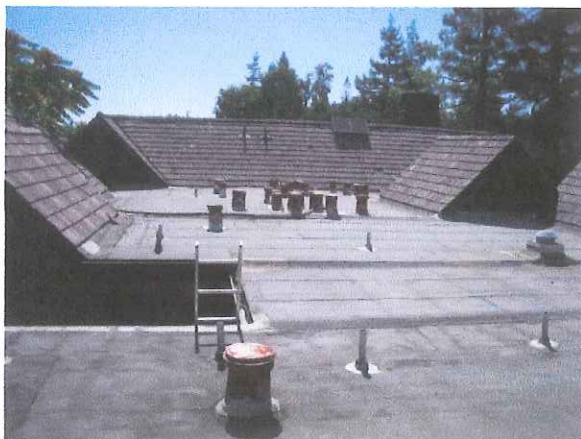
**Building 4**

General view of main roof.

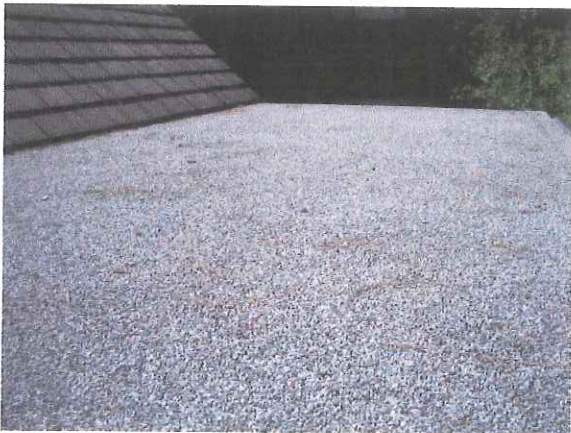
### Garage 4166

View of gravel roof.

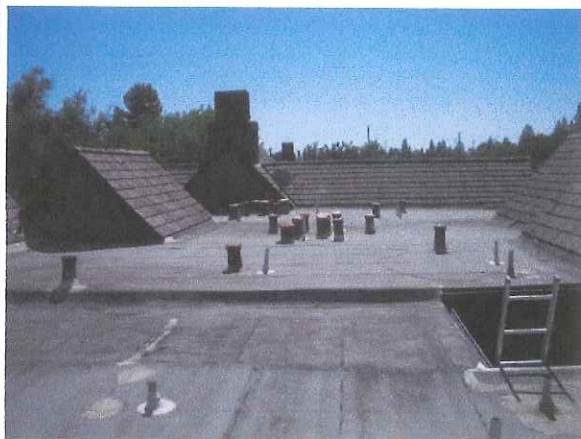
## Building 5

General view of main roof.

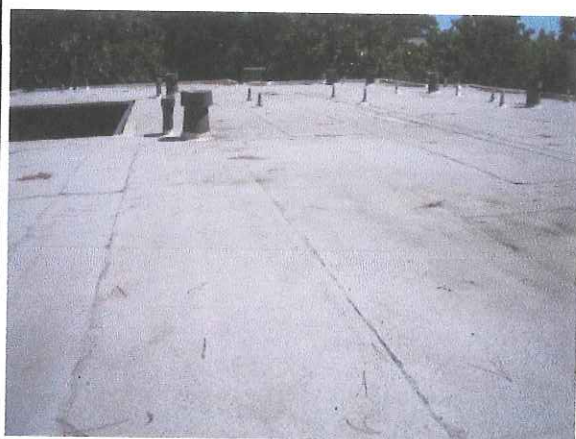
**Building 6**

General view of main roof.

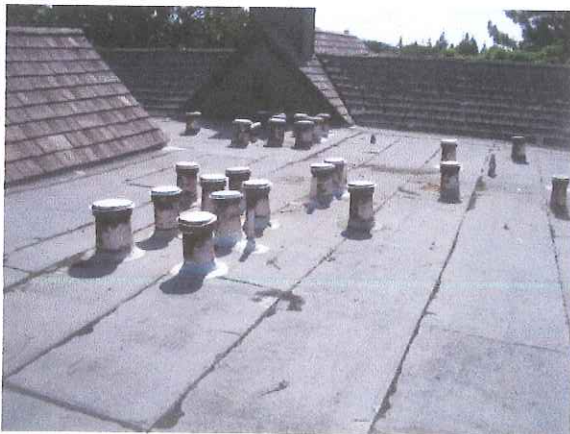
### Building 7

General view of main roof. About half of this main roof is the old cap sheet system.

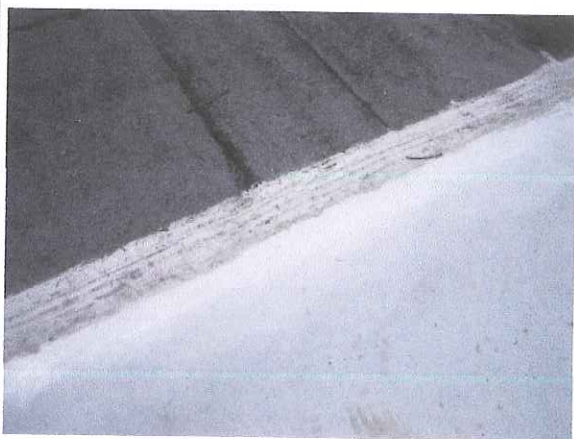
Roof tie in from old cap sheet membrane to new TPO membrane is susceptible to separation and requires frequent maintenance.

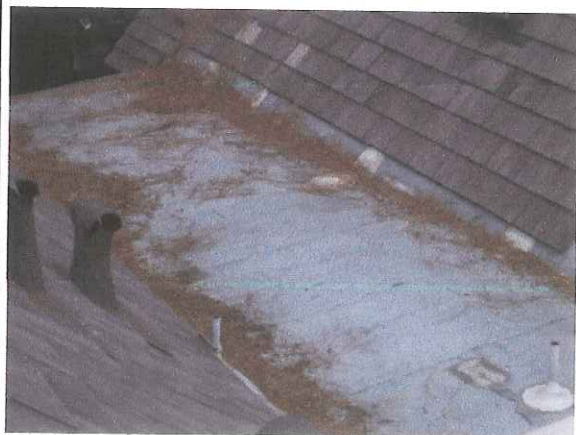
**Building 9**

General view of roof, note debris.

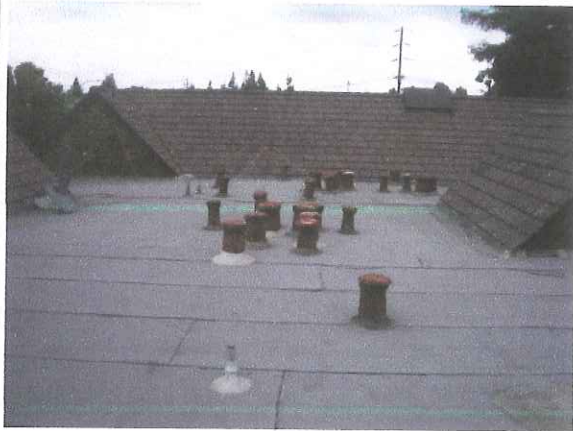
**Building 10**

General view of main roof.

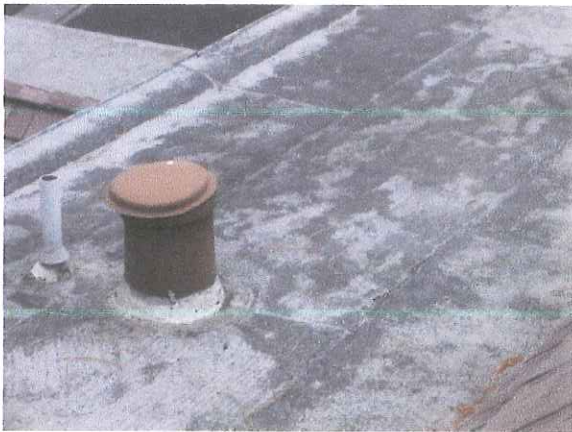
Again, extensive granule loss.

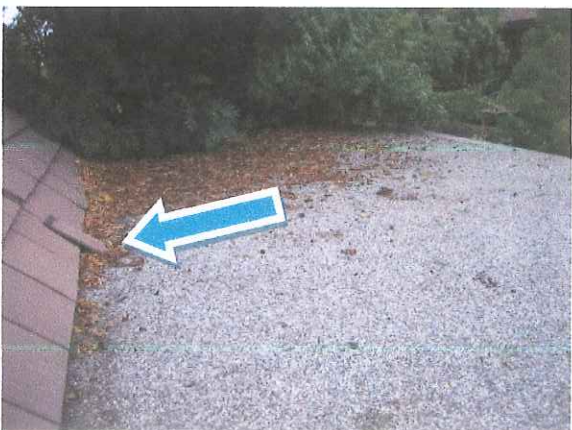
**Garage 539**

Note overhanging tree and tree debris on roof.  
Also note fallen shingle.

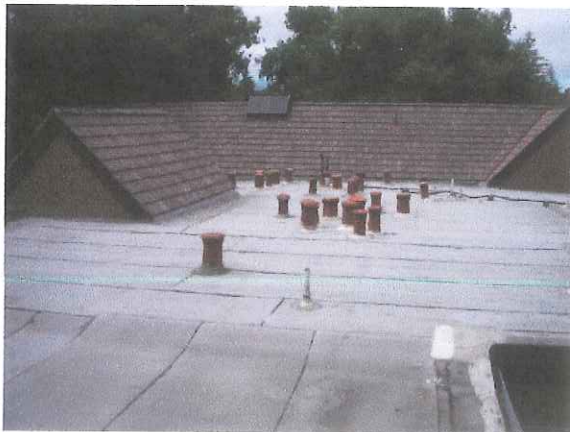
**Building 11**

General view of main roof.

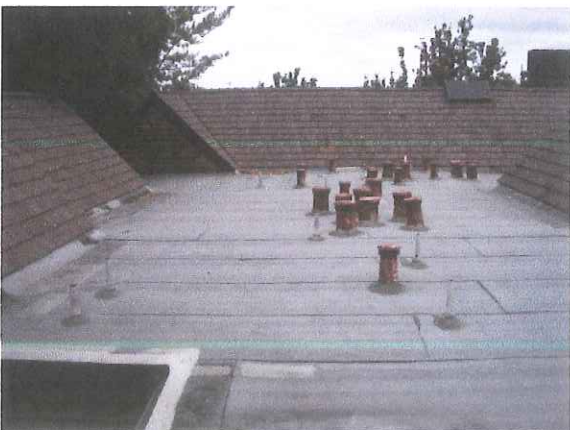
**Building 12**

General view of main roof.

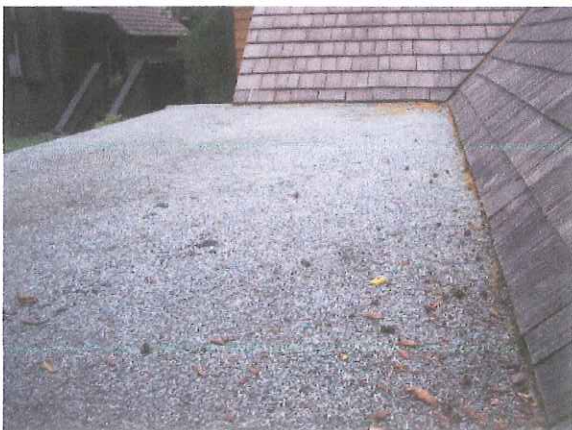
**Garage 4141**

View of gravel roof.

Fair

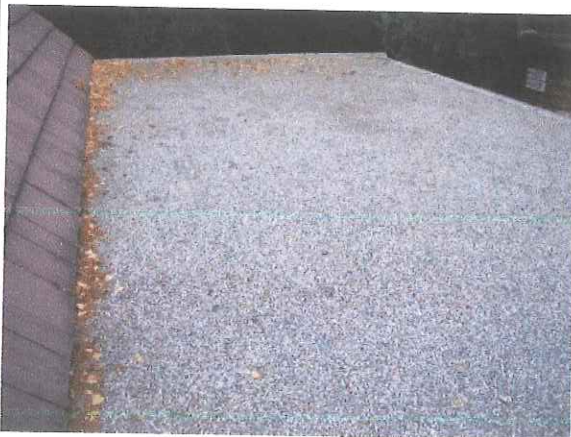
### Garage 4135

View of gravel roof.

Fair

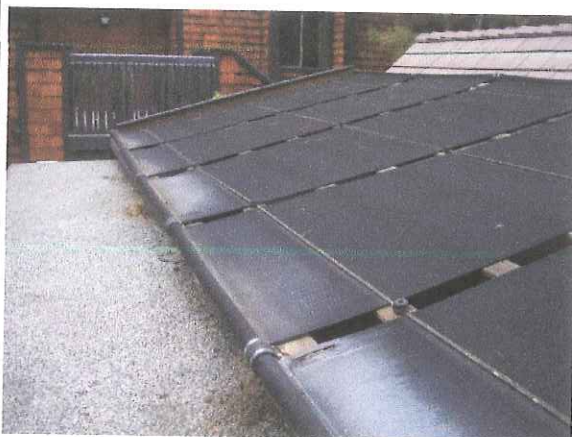
### Garage 4131

For the most part the garage roofs are in fair condition with the exception of garage 4131 which has the pool solar panels. This roof is in very poor condition.

This garage has the pool solar panels installed over most of the roof surface. To reroof the panels will have to be removed.

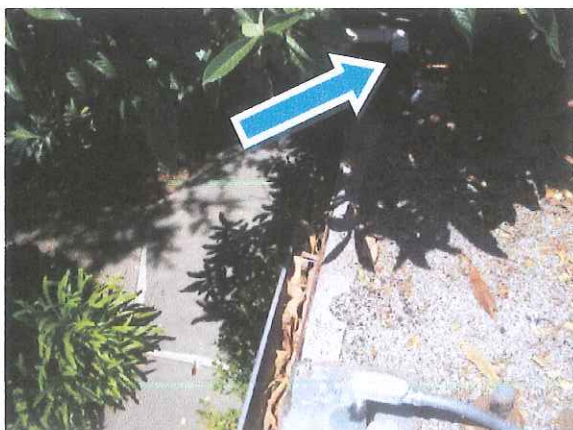
Note solar panel pipes are not sealed well at the penetration and will have to be removed to accommodate the reroof process.
